In the early hours of Wednesday 3rd December 2003, a major storm caused a torrential downpour in a few northern suburbs. A much larger area of Melbourne's north received moderately heavy rains over a two hour period.

However, water marks on concrete structures in Moonee Ponds Creek downstream of Arden Street, North Melbourne, show that the high water mark was within a metre of flooding railway sidings on the North Melbourne (east) bank, and the West Melbourne Terminal Station electricity facility on the western side of the creek.

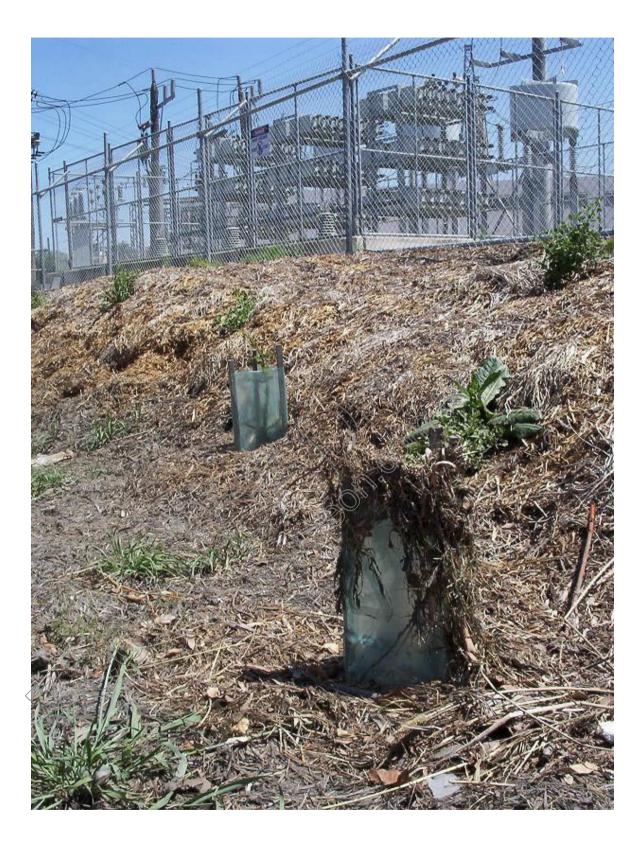
Debris on a tree-guard, about 1.5 to 2 metres below No3. Capacitor Bank

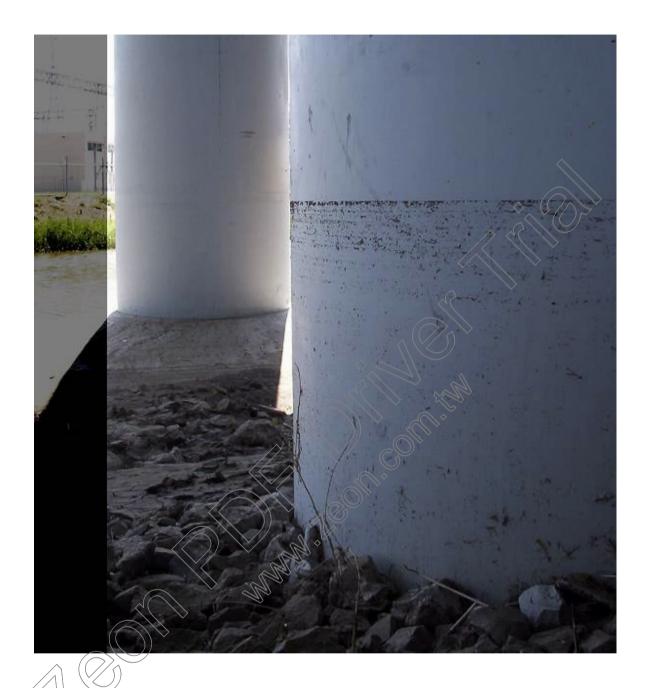
CityLink pyton clearly showing top of flood level. Camera lens waxactly positioned at that height, so the line on the picture accurately shows peak water level on the opposite bank of the creek, barely one metre below ground level in the terminal station.

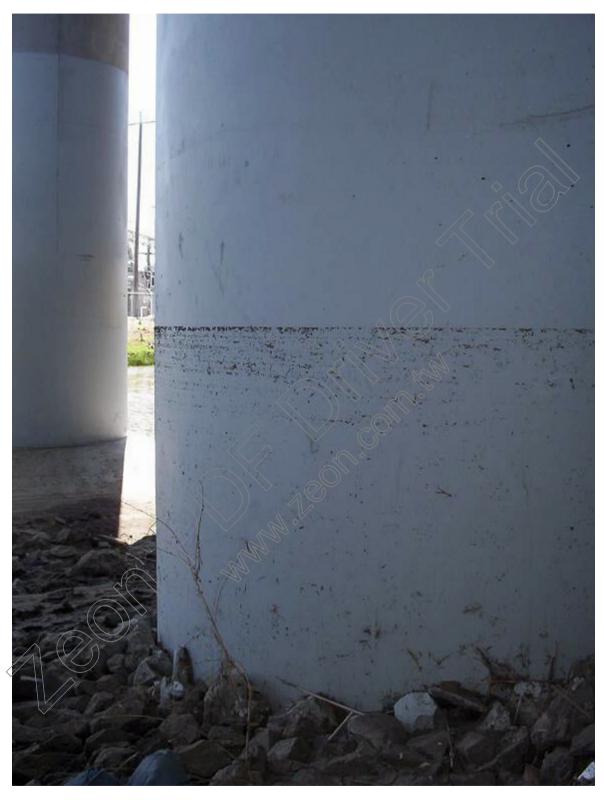
Infrastructure at the terminal staion can clearly be seen between the two concrete columns. Again, the peak flood level mark demonstrates less than one metre clearance between flood height and TS ground level.
